Groton Heights School – Structural Evaluation

FROM: Craig S. French, P.E.

DATE: February 24, 2016; Revised April 14, 2016

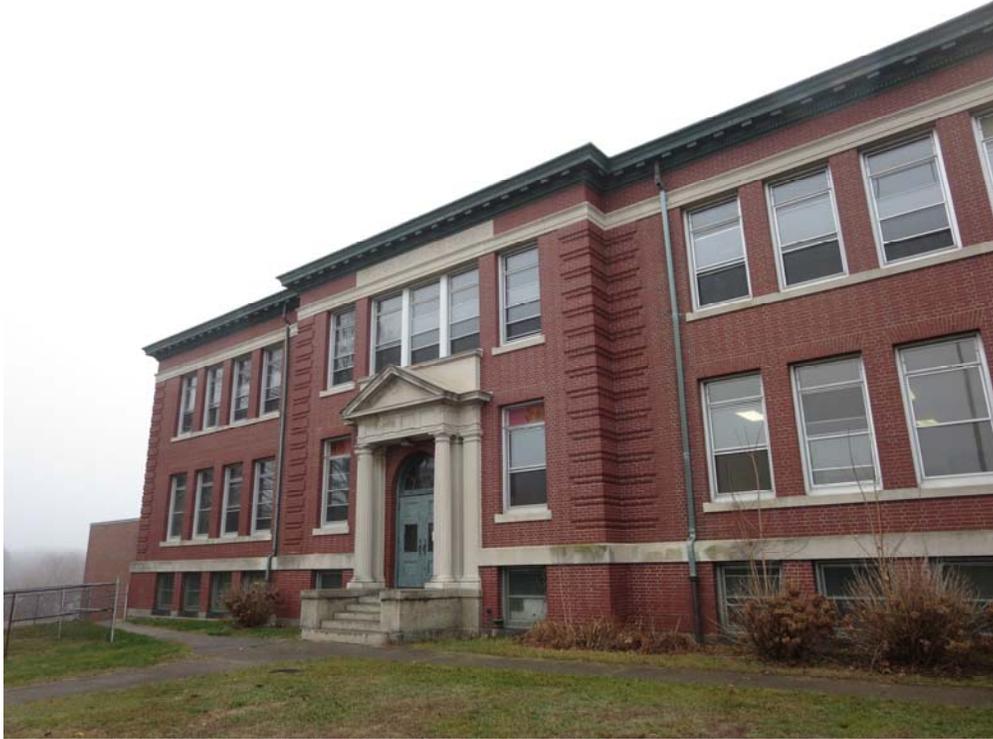
According to information provided, the main building was constructed in 1912 and there was an addition to the building (likely the Gymnasium section) built in 1962. The main building has three levels, two above ground and the lower level is partially below grade (**Photo 01**). The main exterior supporting elements are multi-width unreinforced brick masonry bearing walls. The interior supporting systems appeared to be wood framing with a combination of masonry walls and steel, or possibly cast iron based on the age of the building, columns. The interior framing could not be verified everywhere as there were gypsum ceilings and wall finishes throughout the building.

Photo 1: Front Elevation of Groton Heights School

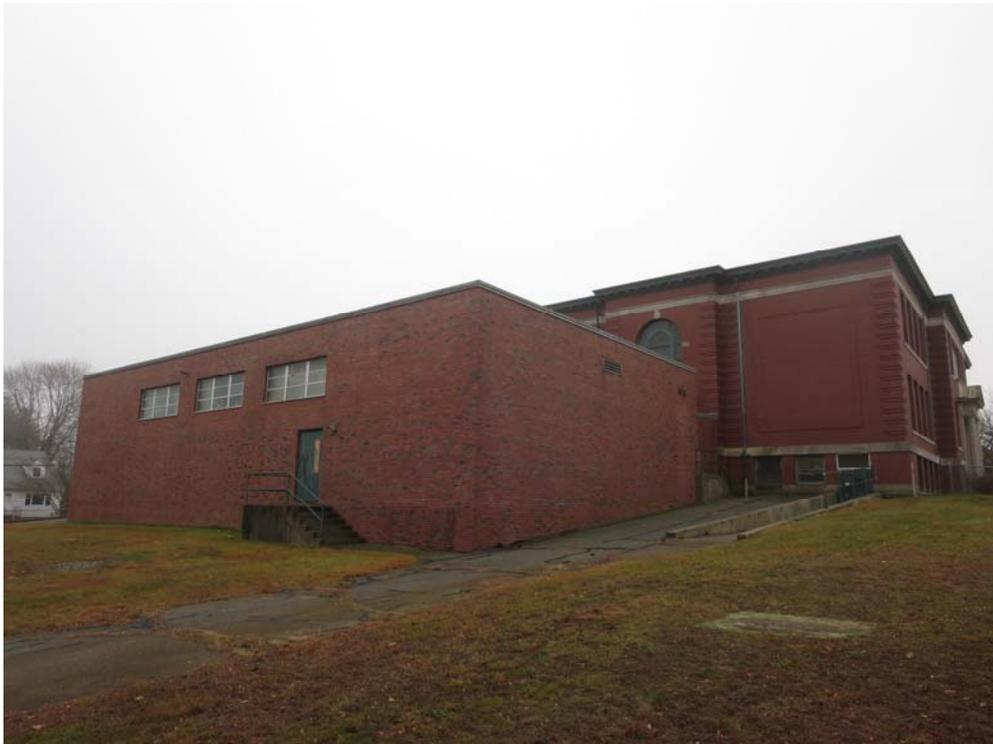
The Gymnasium building is two stories high and is constructed on a sloped portion of the site (**Photo 02**). The exterior support for the building is a combination of brick masonry pilasters with CMU block infill walls between the pilasters. The roof framing is long span metal trusses with a metal roof deck (**Photo 03**).

Photo 2: North Side of Gymnasium Building

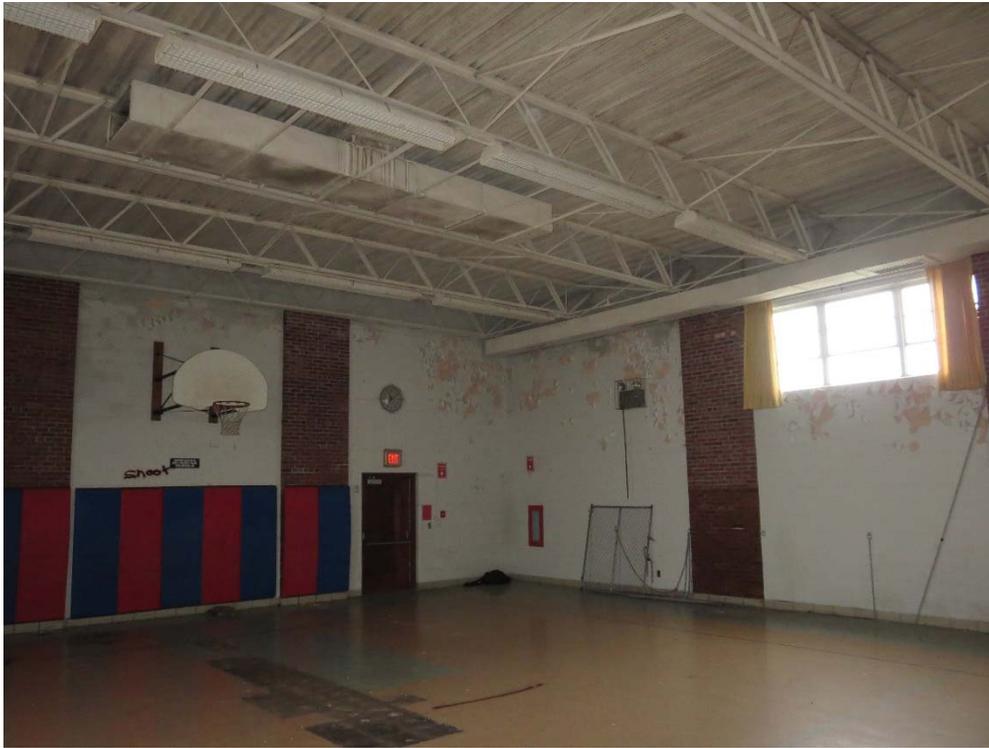
Photo 3: Gymnasium Roof Framing

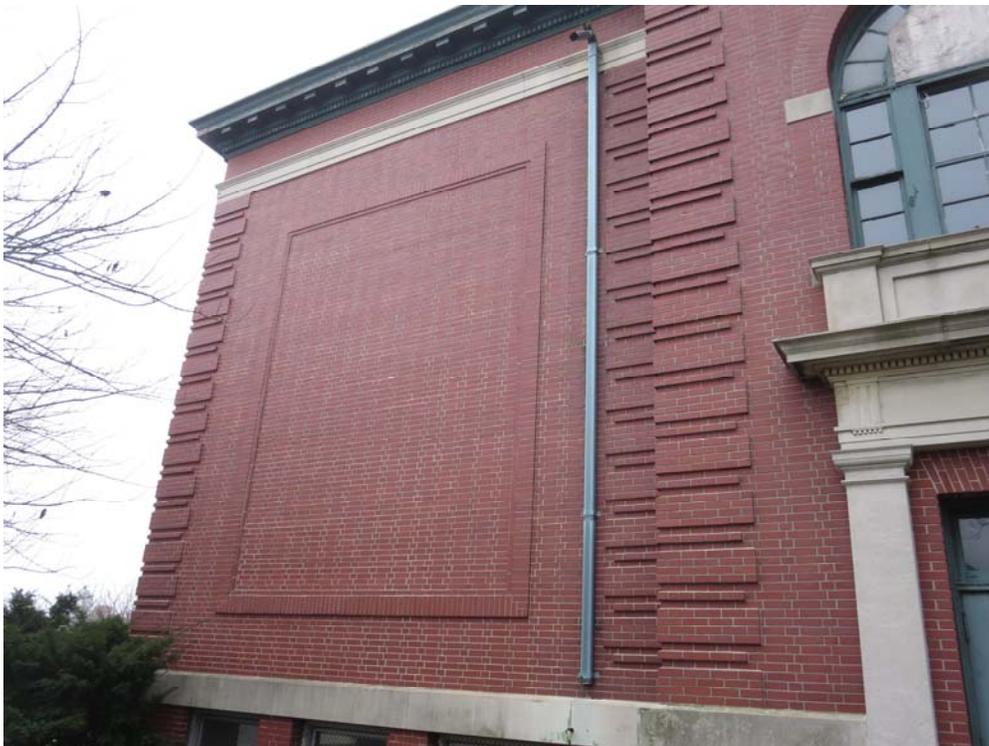
Main Building - The exterior of the main building appeared to be in good condition, with some isolated areas of deterioration in fair condition. Overall the brick work on the building’s exterior was sound and without significant cracks or spalls. The mortar was in place and had not deteriorated and generally the brick units were not displaced (**Photo 04**).

Photo 4: Typical Exterior Masonry Conditions

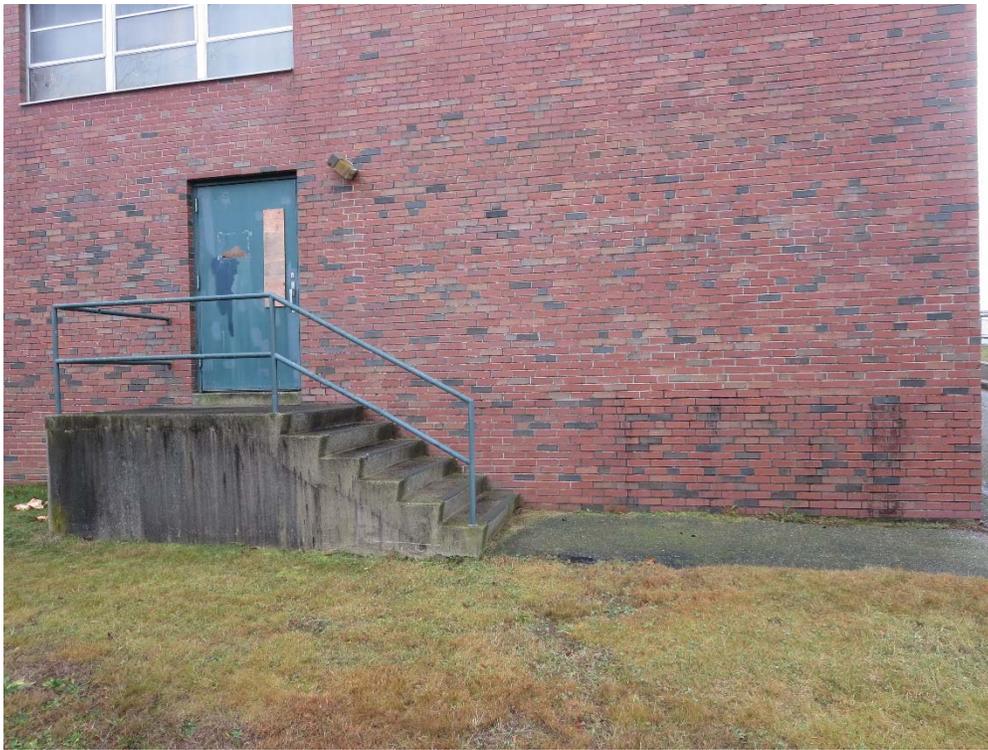
The wood roof eave appeared from the ground to be in at least fair to good condition. Some isolated areas of peeled paint were noted, but no widespread significant rot or damaged portions were apparent at the time of our review. There was one location on the east face of the building that appeared to have damaged wood eave. The brick below currently did not show signs of water damaged, but if the opening in the wood is left unattended, the brick will begin to deteriorate as water penetrates the building envelope.

Photo 5: Deteriorated Brick Masonry

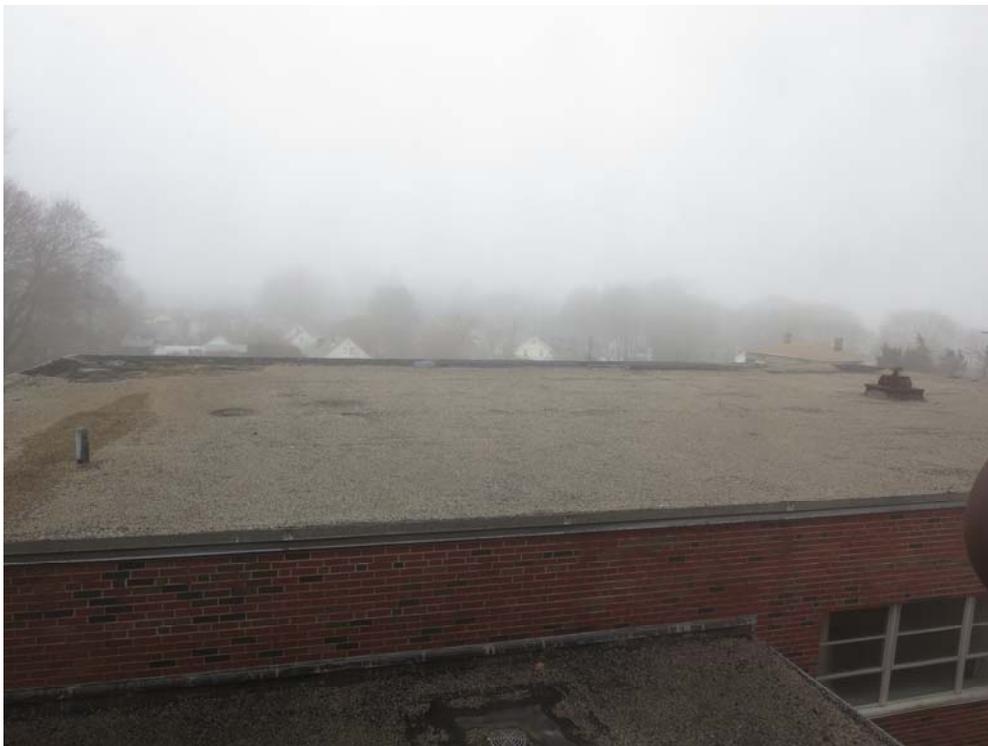
The roofs of the buildings are a stone ballasted Built up Roof (BUR) system. Access to the roof was through a small hatch at the top of the main stair towers. The Gymnasium and connecting structure's roof could be visually reviewed from the roof of the main building (**Photo 06**).

Overall the Gymnasium roof appeared to be in fair to poor condition. There were several wet locations noted on the gymnasium roof, mostly along the north edge of the roof. Generally the stone ballast appeared to be in place, with some areas of exposed membrane around the roof. No significant vegetation growth on the roof was noted, which typically indicates areas of ponding water and sediment build up. There was a large section of the Gymnasium roof in the northwest corner where it appeared the stone has been removed and the membrane is currently exposed; there was heavy moisture in this area noted during the review of the gymnasium interior. The roof of the small connector building was in similar condition to the gymnasium.

Photo 6: Roof of Gymnasium

A new roof for both the main building and the gymnasium will significantly reduce the advancement of the deterioration in both buildings. Currently it does not appear that the masonry bearing walls have deteriorated to a point where their capacities would be reduced. However, water and moisture infiltration into a building of this type of construction, significantly accelerates the deterioration process.

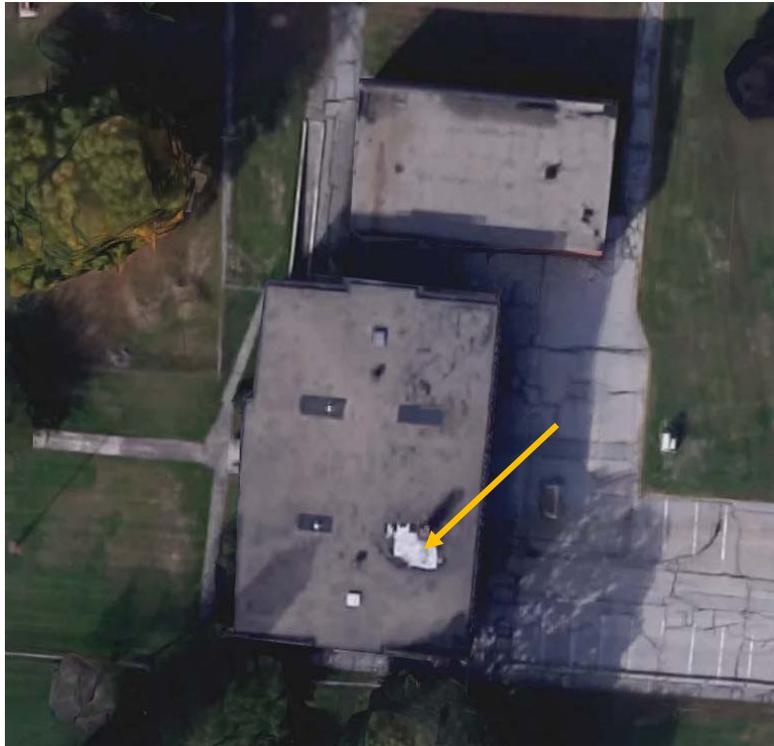
The roof of the main building was similar construction as the gymnasium with a stone ballast BUR system. The majority of the main building's roof was in fair condition, with a large section that was compromised in the south east portion of the roof. An aerial view of the building clearly shows the area of the roof where the system has failed (**Photo 07**). This deteriorated portion of the roof was confirmed from the interior review of the building, where there was heavy water damage noted.

Photo 7: Overall Roof Plan of Groton Heights School (note failure of roof covering)

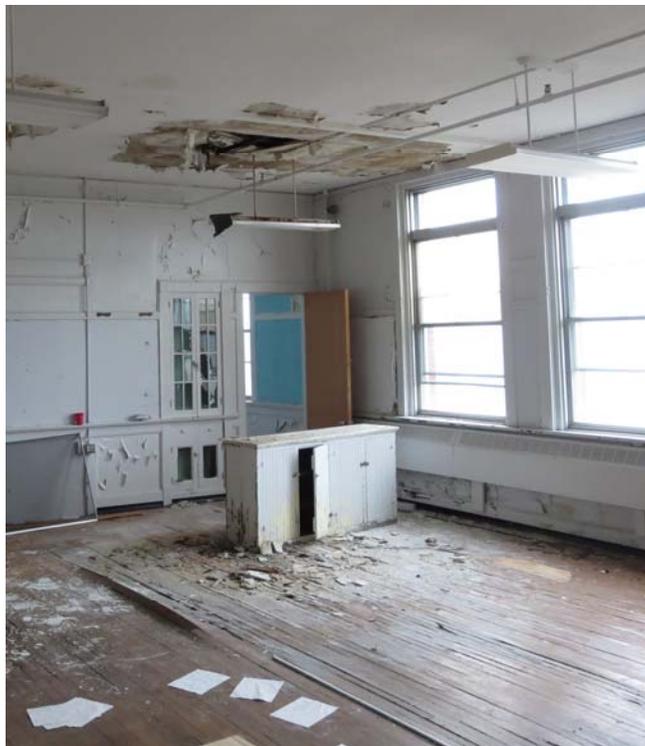
Overall the second floor of the building is in fair condition, however room 6, located in the south east section of the building is in poor condition. Room 6 has heavy water damage and portions of the finished ceiling have failed (**Photo 08**). The location of the ceiling failure appeared to be in the general area of the compromised roof covering as noted in the roof portion of the report. At the time of our inspection, it did not appear that the structural roof framing has significantly deteriorated, however based on the extent of water damage noted there is likely some damage to the wood roof framing.

The floor of room 6 has also sustained heavy water damage, with the finished hardwood floor buckled and deteriorated. Overall the walls have some water damage, but not to the extent of the ceiling or floor. The heavy damaged area of room 6 is generally contained to the portion directly surrounding the roof leak; the far south end of the room (away from the roof leak) has significantly reduced damage.

Photo 8: Water Damage in Second Floor Classroom

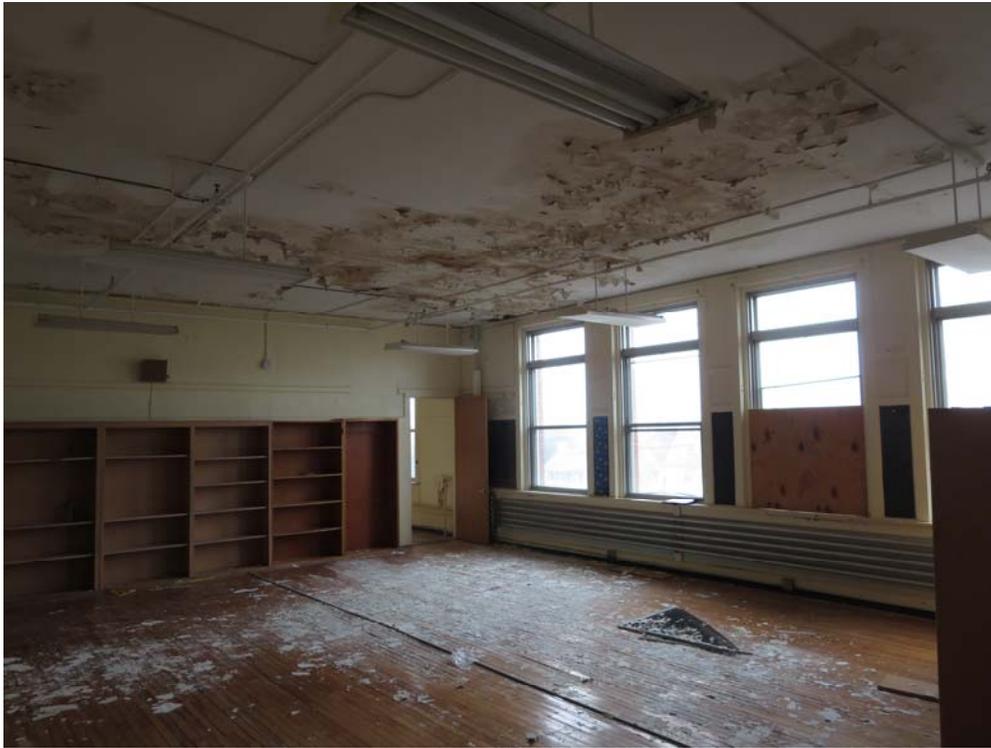
Overall the first floor of the building is in at least fair condition, with the majority of the floor in good condition. Room 1, which is in the south east portion of the building, directly below room 6, has heavy water damage to the ceiling and minor water damage to the floor (**Photo 09**). At this time the ceiling finishes have not failed, however it appears imminent that this will occur soon. There is a significantly wet area adjacent to the east wall where mold appears to be beginning to form. Mold abatement will likely be required prior to or during building renovations. Abatement may include removal of select flooring components.

Photo 9: Continuation of Water Penetration in First Floor Classroom

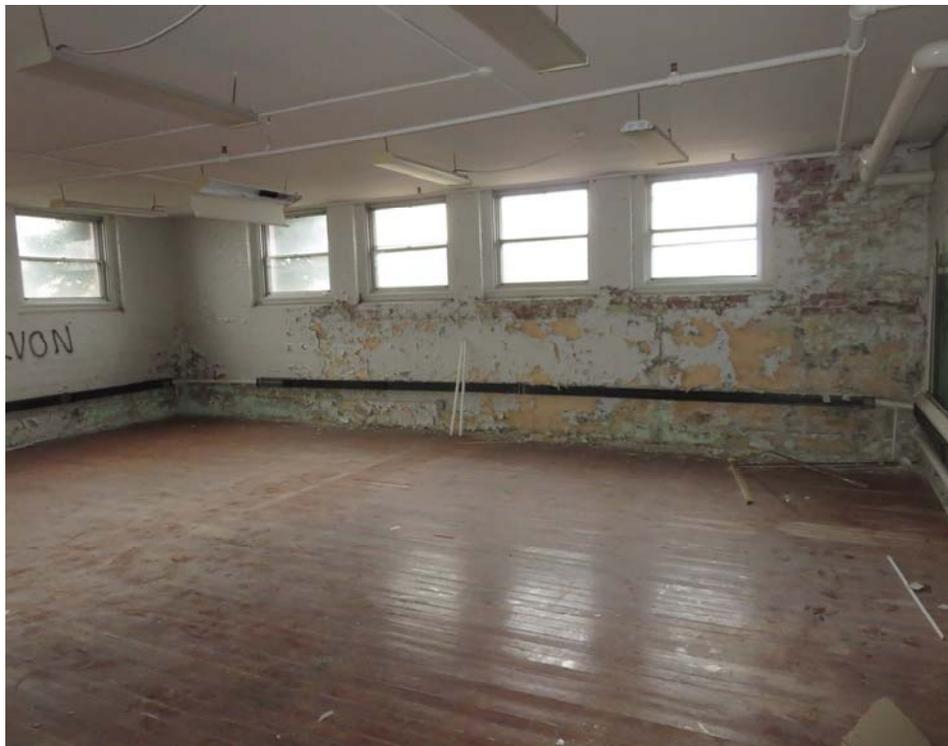
Room 12, located in the south west corner of the lower level, has the heaviest amount of moisture on the walls. The west exterior wall has peeling paint throughout the length and height of the wall and there are isolated portions of the masonry that appeared to be softening (**Photo 10**). In addition, the south side wall also has widespread peeling paint. The ceiling in this room appeared intact without water damage.

Photo 10: Moisture Damage to Brick in Basement Level Classroom

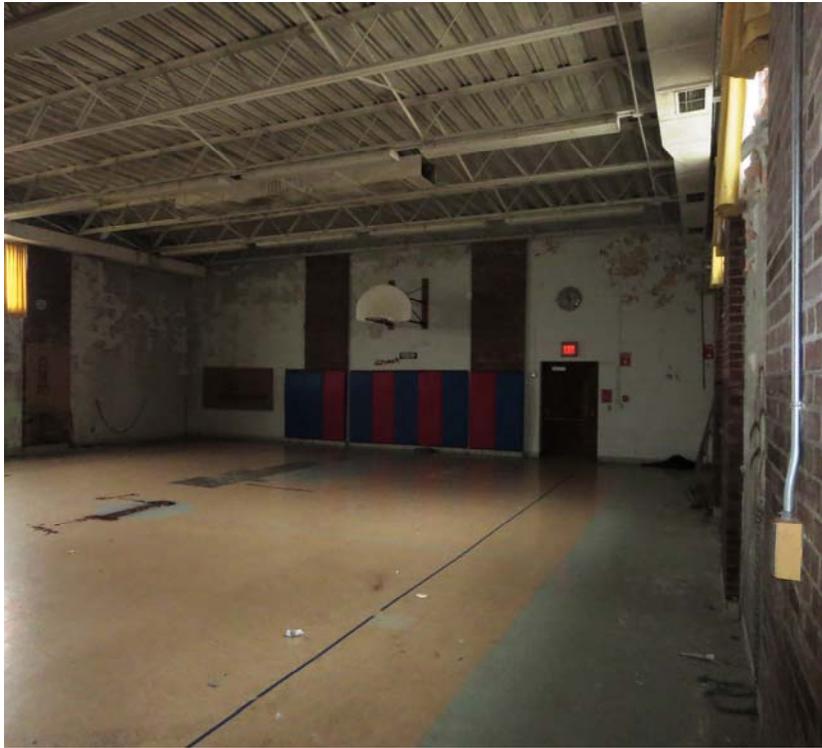
The gymnasium structure has heavy moisture and water damage throughout the building (**Photo 11**). The roof has areas of rust and the walls have widespread paint peeling and water staining. The stage has been significantly impacted by water damage. Structurally the gymnasium is in fair condition, although the water damage is widespread, it does not appear to have significantly affected the building's structural systems at this time. It is apparent that deterioration of the brick masonry and areas of rusting roof members are advancing and if left unchecked will eventually reach poor condition and ultimately begin to fail; however at this time the structural integrity of the building does not appear to be an issue (**Photo 12**).

The gymnasium building has very high humidity and mold presence, and these conditions make occupancy of the space unlikely. However with what appears to be only minor rust; the structural capacity of the space does not appear to be significantly affected. There is some apparent deterioration of the north masonry wall below the floor slab elevation, which should be investigated and repaired. There were not global deficiencies or signs of future failures noted at the time of our review. Similar to the main building, the roof should be investigated to be replaced to slow the deterioration of the masonry walls and steel roof trusses.

Photo 11: Heavy Moisture / Mold Apparent in Gymnasium

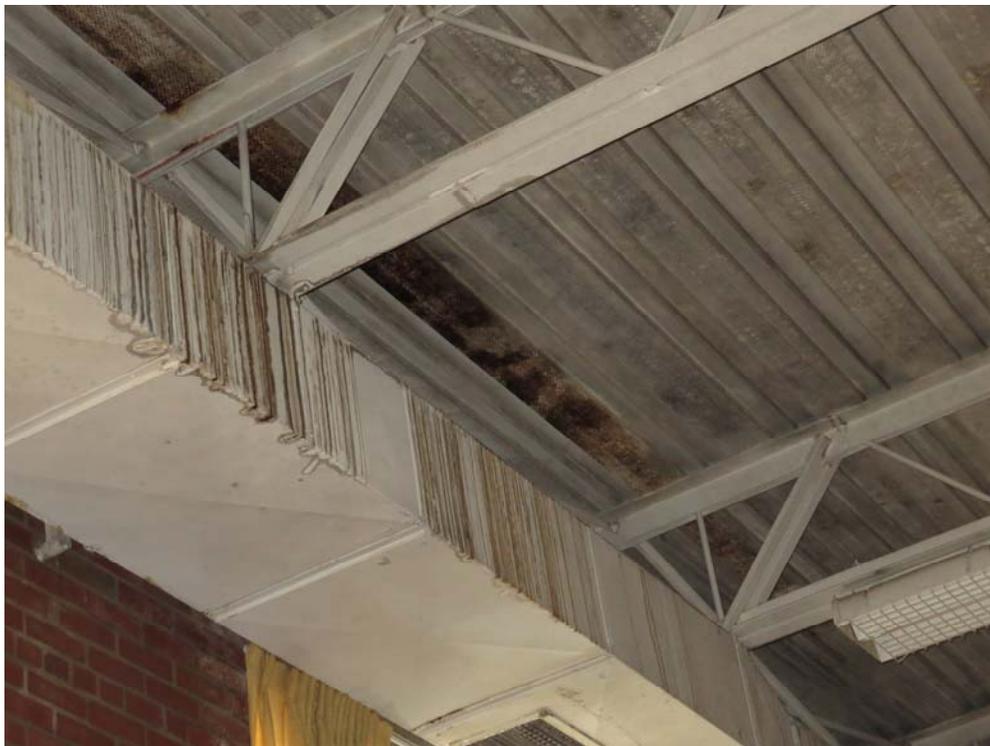
The roof of the gymnasium appeared to have several areas where the envelope had been compromised and it is apparent that the likely source of the moisture penetration originates from the roof. A condition that could not be verified from the interior is the potential deterioration of the brick masonry below the slab elevation. As noted from the exterior, there is a definite horizontal line along the outside wall at approximately the slab elevation. This condition occurs

Photo 12: Rusted Roof Deck in Gymnasium
