Groton Heights School – Electrical Evaluation

FROM: Ron Maniscalco, P.E.

DATE: February 24, 2016; Revised May 31, 2016

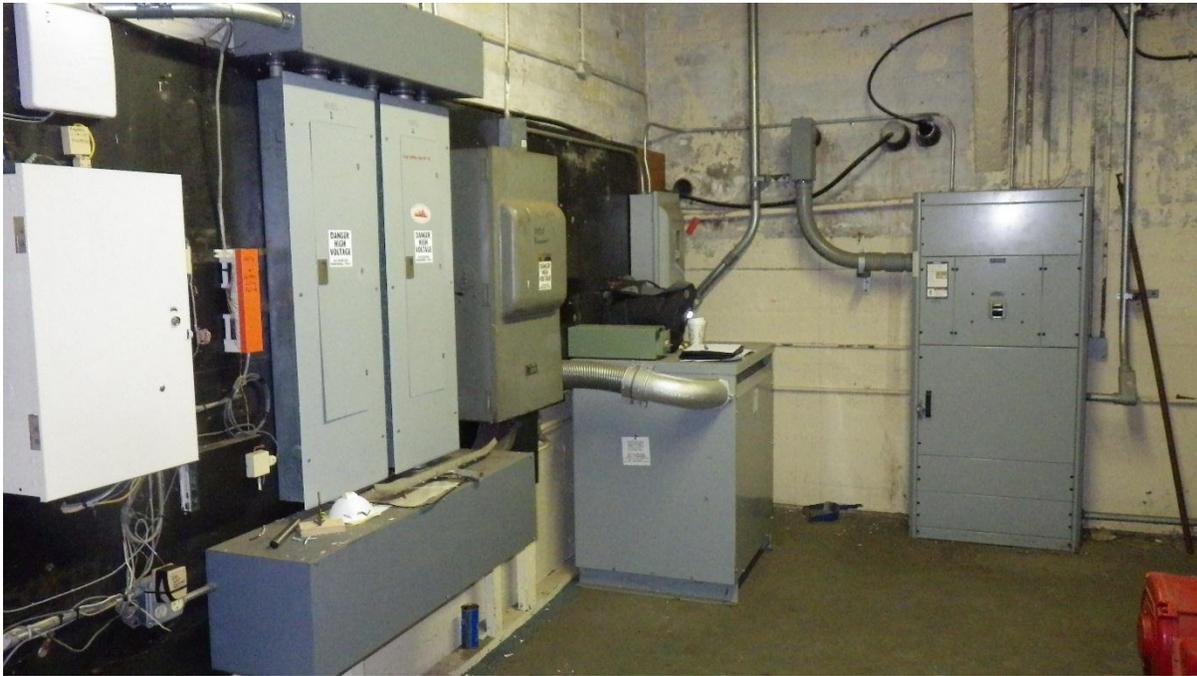
Electrical Service Entrance

The existing electrical service originates at the overhead utility pole #22-1 on Smith Street. From the pole service goes underground to a pad mounted utility transformer located on the east side of the building. From the pad mounted transformer there are two 480 volt underground electrical services that enter the building. Each service has a dedicated utility meter that has been enclosed with a lockable metal cover.

The main service to the building is protected by a 200 amp fused disconnect switch with 200 amp fuses in the boiler room. From the fused disconnect switch the conductors enter a 150 kVA floor mounted transformer located in the boiler room. This is the only electrical power transformer in the building. It appears that the building was originally fed with a 120/208 volt three phase service. In the year 2000 the electrical service was upgraded to 480 volts. The transformer and the fused disconnect switch are both 15 years old and well maintained.

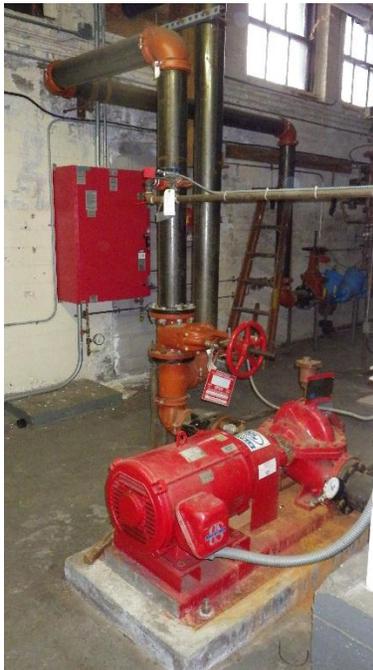
Fire Pump

The second electrical service is dedicated to the 60 HP electric fire pump. The second service is protected by a 600 amp circuit breaker and directly feeds the fire pump controller. The 600 amp circuit breaker, the fire pump controller and the fire pump are all located in the building boiler room. The building's fire pump system was added in 2000. The 600 amp circuit breakers, the fire pump controller and the fire pump are all 15 years old and well maintained.

The existing electrical fire pump is in good condition and well maintained.

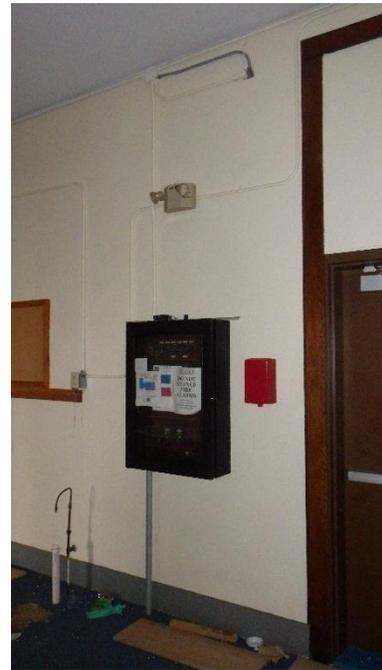
Fire Alarm

The building has a Simplex non-addressable fire alarm panel in the first floor hallway. There are currently five zones in the building. There is one zone for each of the three floors, one zone for the gym and one zone for the sprinkler system. The fire alarm system is powered from Panelboard #2, circuit #18. The fire alarm panel has been maintained throughout the time the building has been unoccupied. The last service dated indicated on the control panel was November 23rd, 2015.

The existing fire alarm system is suitable for the basic needs of the building. Additional modification to the fire alarm system may be necessary depending upon the future use of the building.

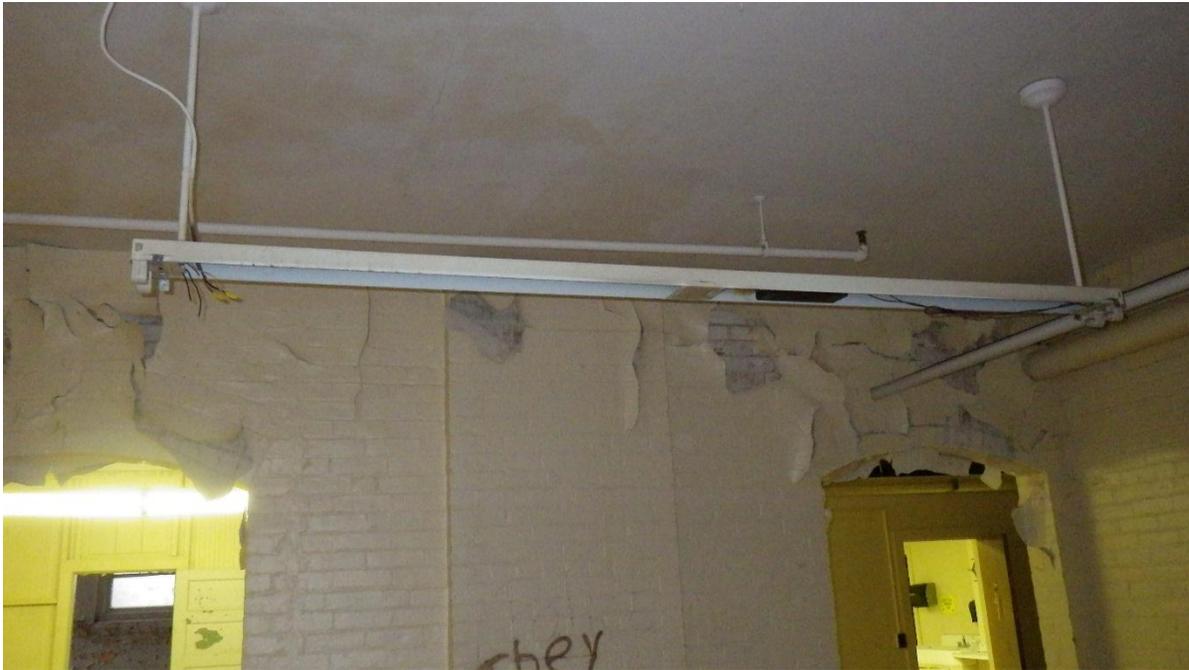
Typical Lighting Fixtures

The interior spaces are illuminated with multiple pendant mounted fluorescent lighting fixtures. In the classrooms, these fixtures are mostly four lamp stem mounted 2'x4' wrap around fixtures. On the basement level there is one classroom that has two-lamp stem mounted 1'x4' "ice cube tray" type lighting fixtures. In the hallways, boiler room and gymnasium, there are two lamp pendant mounted 1'x8' industrial strip fixtures. On the stage there are two lamp grid mounted lighting fixtures with "egg-crate" baffles.

The existing lighting fixtures are outdated and should be replaced with more efficient lighting. The conductors should also be replaced as they have reached the end of their useful life.

Remove and replace the existing interior and exterior lighting with energy efficient lighting fixtures. Properly dispose of the housings, wiring, and ballasts. Any ballast containing PCB's shall be disposed of as hazardous waste.

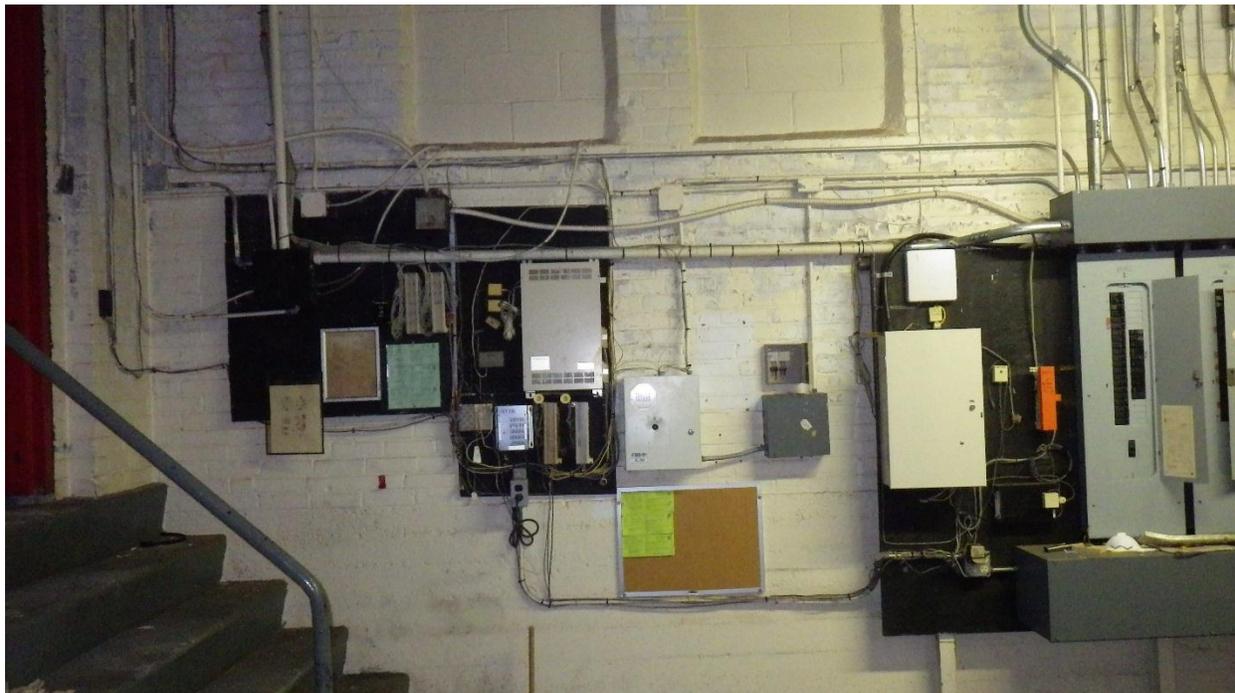
Telephone and Security Headend Line Up

The building is serviced with a 25 pair telephone service originating from pole #22-1. The building has a standard "plain-old-telephone-service" (POTS) that is terminated in a box in the boiler room. There are 110 punch-down blocks for telephone service to other areas of the building.

Security at the building is provided by a Fire Burglary Instrumentation (FBI) Inc. intrusion detection system. The FBI system has a XL-4B monitoring panel located in the boiler room. There is also an autodialer mounted on the wall adjacent to the monitoring panel. The system is currently monitored by Alarm Guard Inc.

The existing telephone service is very basic. The service will support a facility with simple needs.

The existing telephone service should be upgraded to accommodate the future use of the building.

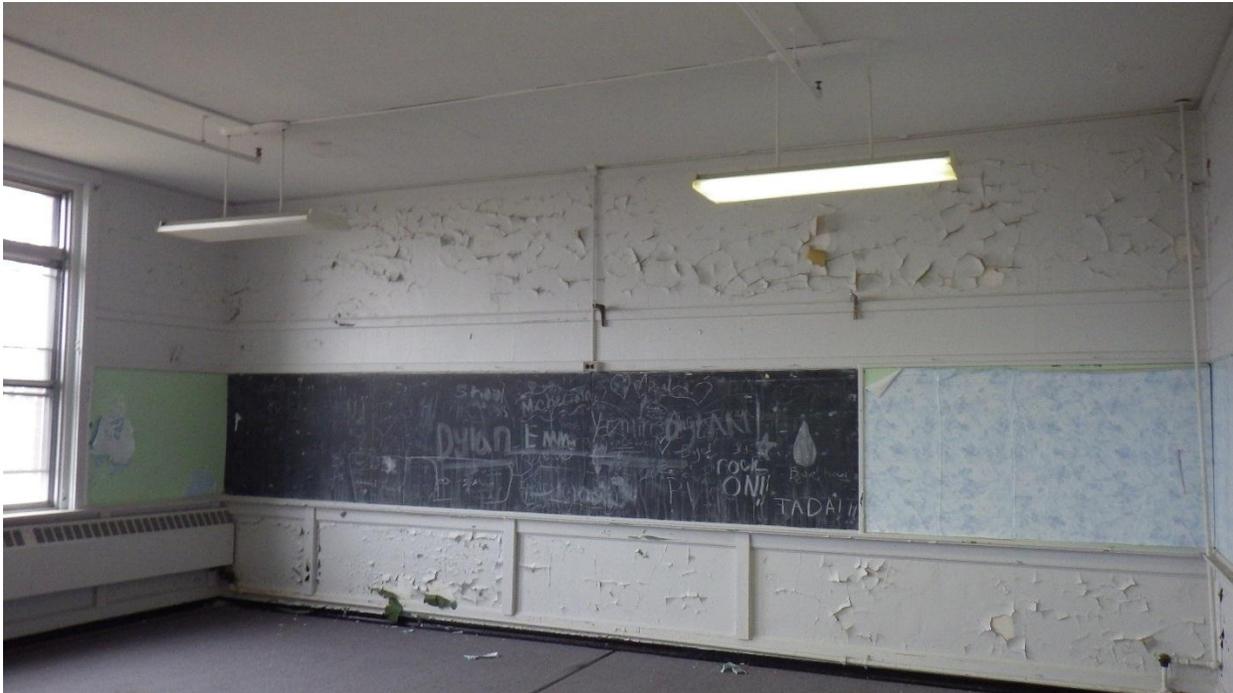
Typical Classroom Lighting

The interior lighting is controlled with local wall mounted toggle switches. In the classrooms there are two switches for dual level lighting. One switch controls the lighting fixtures closest to the windows. The other switch controls the light closest to the interior wall. There are no photocells or occupancy sensors in the building.

Provide energy saving room occupancy sensors in each of the occupied rooms. These could include ceiling, wall, or fixture mounted dual technology motion sensors. It is recommended dual level lighting be installed in stairwells and corridors.
