Groton Heights School – Mechanical Evaluation

DATE: February 24, 2016; Revised May 31, 2016

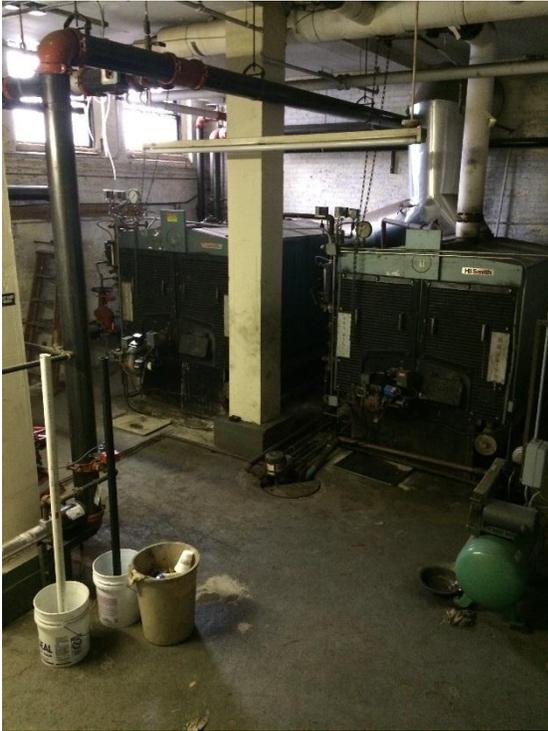
The Groton Heights School is heated by two existing H.B. Smith 450 Mills, number 2 fuel oil fired, low pressure steam boilers. The existing boilers are water tube design with cast iron heat exchanger construction. The existing boilers were not operating at the time of the site visit.

In general, the existing Groton Heights School HVAC systems are significantly outdated and have exceeded their useful service life. The existing oil-fired steam boilers, and the majority of the existing steam perimeter heating terminal units, are estimated to be approximately 50 to 60 years old.

Cast Iron, Oil-fired, Steam Boilers

Due to the availability of more efficient equipment and the estimated age of the existing boilers, we recommend replacement of the existing oil-fired steam boilers with high-efficiency, gas-fired, condensing hot water boilers. Efficiencies of the existing boilers is estimated at 80% when new, as compared to 95-98% for new condensing type hot water boilers. The typical service life expectancy for a cast iron boiler is approximately 35 years, which means the existing Groton Heights School boilers have exceeded their expected useful life span by 15 to 25 years.

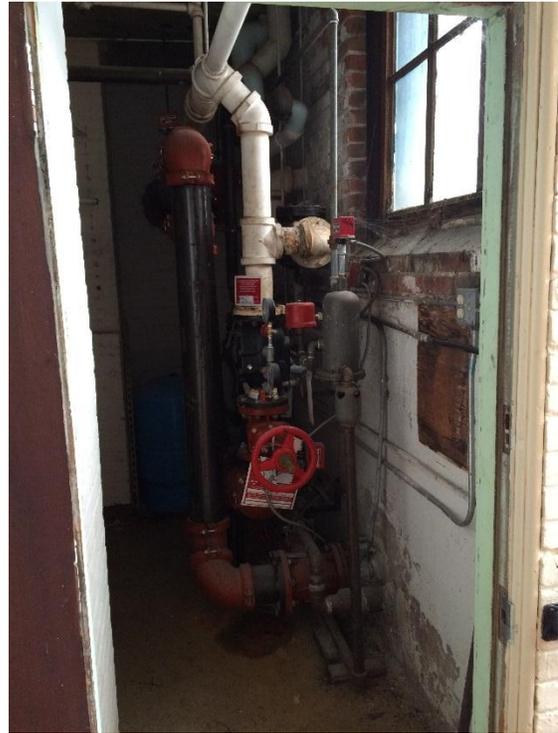
The water service enters the building within a utility closet near the Southeast basement level entrance. The domestic water service pipe enters the building at a size of approximately 4" diameter, but immediately reduces to approximately 2" diameter before entering the building water meter and backflow preventer. Downstream of the backflow preventer there is a domestic water service booster pump and an approximately 20 gallon pressure tank. The domestic water booster pump was not operating at the time of this site visit.

The existing water pressure boosting system was not operating during the time of the site visit. The operational state of the pump and pressure tank is unknown at this time. Pump housing corrosion and signs of previous leak events were observed during the time of the site visit. The base of the pressure tank is also showing signs of rust and corrosion.

Water and Fire Protection Service Entrance

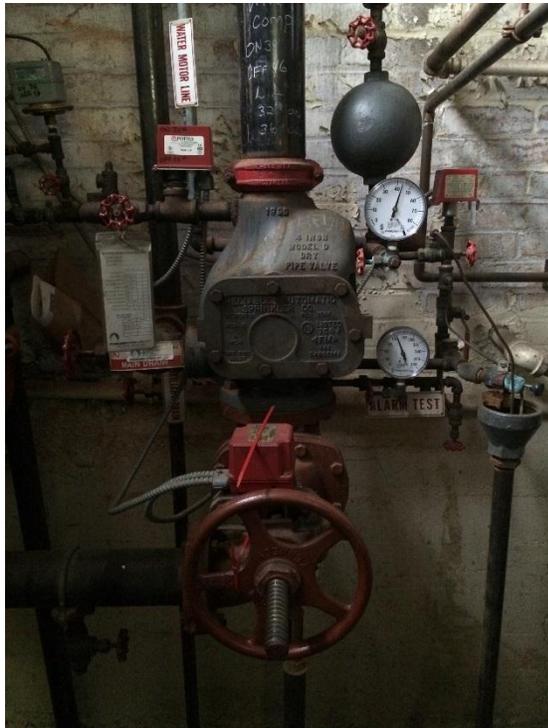
The existing dry and wet pipe alarm valves serving the attic and main building appeared to be in fair condition at the time of the site visit. The dry and wet pipe alarm valves are estimated to be approximately 20 to 30 years old.

Dry Pipe Alarm Valve

The existing Groton Heights School fire sprinkler system should be inspected in further detail by a certified fire protection professional. The inspection should include review in further detail to determine that the existing sprinkler head locations and densities meet current code requirements. The existing fire pump should also be tested by a certified professional to determine proper operation.

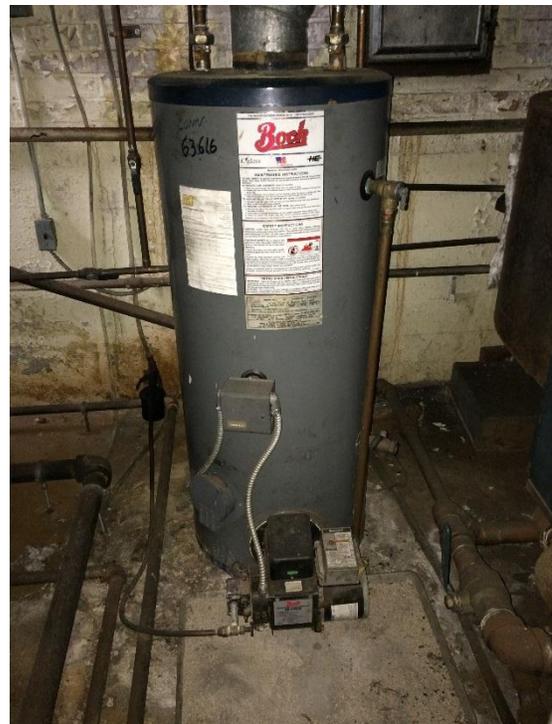
Domestic hot water is produced for the building by an oil-fired, 32 gallon, storage-type water heater located within the basement boiler room. The domestic water heater is located between the two existing oil-fired, steam boilers. The domestic water heater burner is 1/8 horsepower with a firing range of 0.5 to 2.75 gallons per hour. Number 2 fuel oil is supplied to the water heater burner from an underground storage tank located on the east side of the building. The domestic water heater vents into the same brick masonry chimney as the two oil-fired boilers through a breeching approximately 6" in diameter. A domestic hot water recirculation pump is located on the west wall of the boiler room and appeared to be thermostatically controlled. The domestic hot water recirculation pump was not operational during the time of this site visit. A domestic hot water mixing valve was not observed during the time of this site visit.

Domestic hot and cold water piping observed throughout the building appeared to be in good condition with no major signs of corrosion or leaking. The domestic water heater also appeared to be in fair condition with no major signs of corrosion or leaking. It is estimated that the majority of the water distribution piping throughout the building is 50 to 60 years old. The existing oil-fired water heater is estimated to be approximately 10 to 15 years old.

Oil-fired Domestic Water Heater

Due to the availability of more efficient equipment, the existing oil-fired water heater should be replaced with a high-efficiency, gas-fired, condensing water heater. Depending on the future use of the building, fixture quantities, and fixture types, some extent of main domestic hot water and domestic cold water piping could be reused to feed new fixtures in new and/or existing locations.

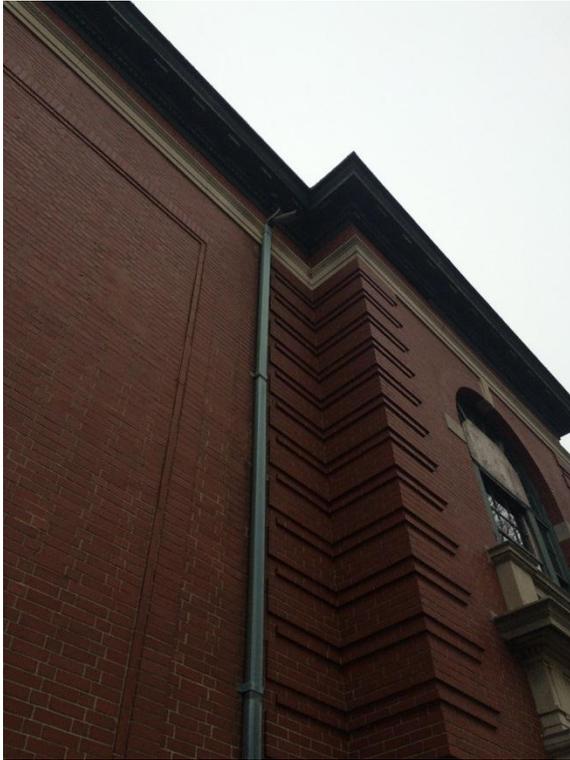
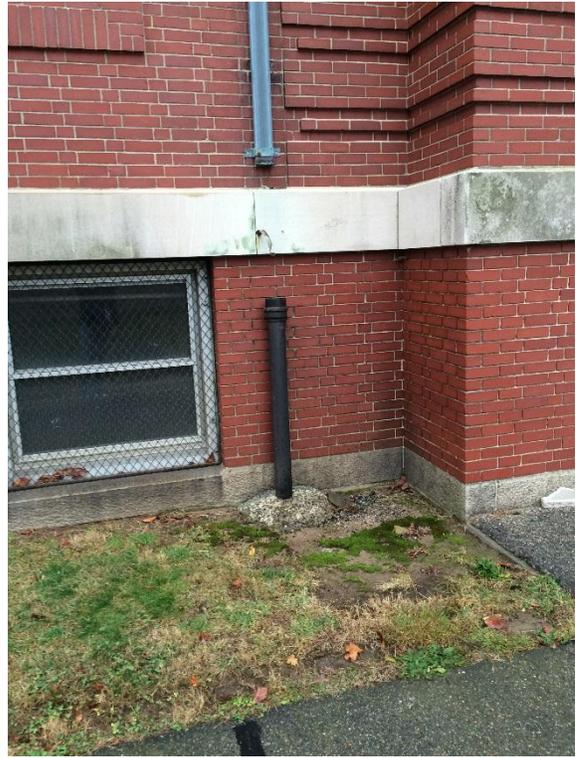
Given the poor condition of the existing roof, and recommendations for replacement, it is assumed that the existing scupper drains are also in poor condition and in need of replacement. Based on observations made from the ground around the exterior perimeter of the building, the existing downspout system serving the main building roof is generally in poor condition. Downspouts at several locations are no longer connected to their associated standpipe and downspout elbows in several locations are showing signs of deterioration.

Typical Damaged Downspout

The existing roof drainage system will need to be analyzed further to determine whether it meets current building code based on roof areas, quantity of roof drains, and sizing of storm drainage piping systems. If the existing quantity of roof drains and sizing of storm drainage piping is determined to be adequate, at a minimum the existing scupper drains and downspouts should be replaced due to their current poor condition.

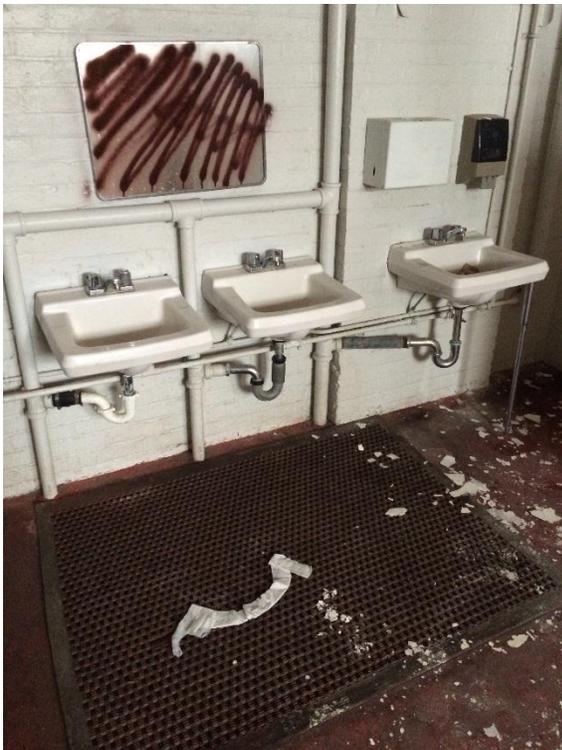
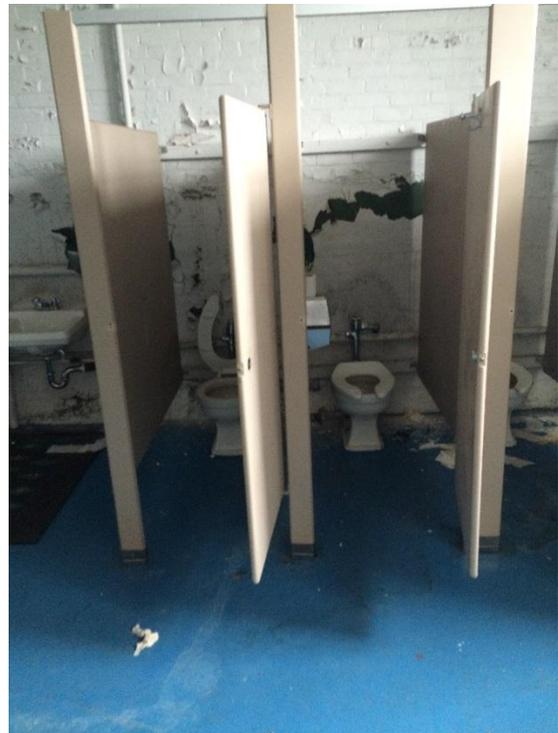
Plumbing fixtures throughout the building are outdated, and may have flow rates exceeding the maximum allowable by code. Additionally, many plumbing fixtures are not in compliance with the requirements of the American with Disabilities Act (ADA).

Typical Plumbing Fixtures

Due to the availability of more efficient plumbing fixtures, the estimated age of existing fixtures, and code requirements, all existing plumbing fixtures at the Groton Heights School should be replaced. New plumbing fixtures should be code compliant with respect to flow rates. The implementation of further reduced, low-flow water saving fixtures should be

considered where appropriate. New plumbing fixtures must also be ADA compliant where required.

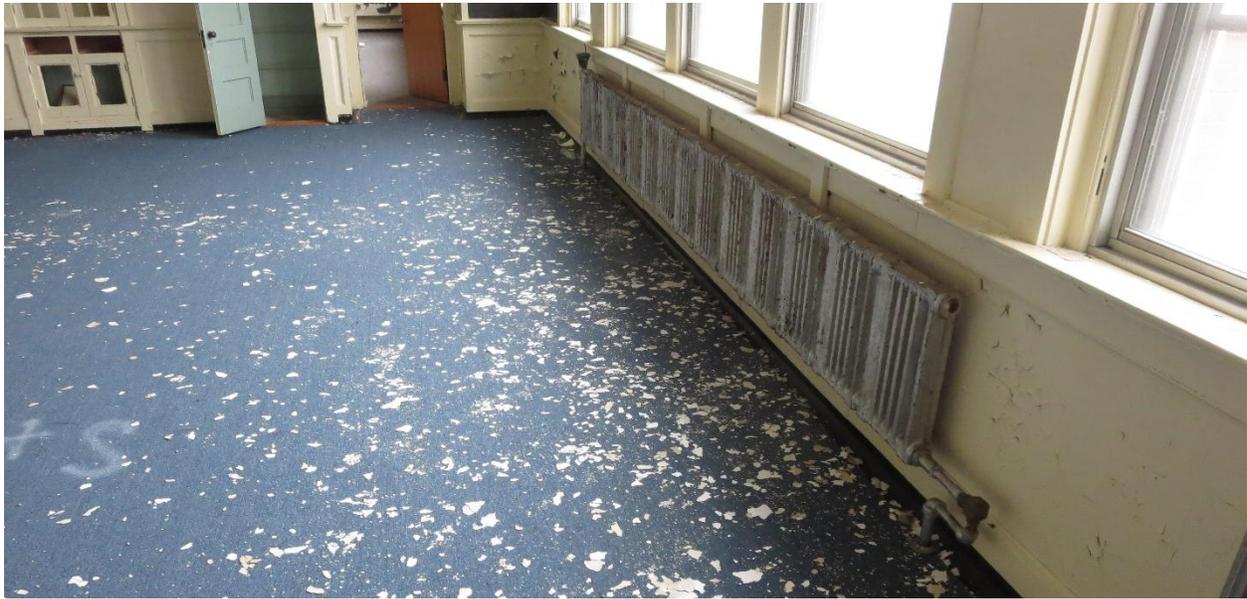
Miscellaneous steam convectors, cast iron radiators, and bare steel pipe radiators were also observed in various locations throughout the building. Each typical classroom is served by a continuous length of steam heating finned tube radiation controlled by a pneumatic thermostat and pneumatically operated two-way control valve.

Typical Cast Iron Steam Radiator

Implementing condensing boilers to produce heating hot water would also require the installation of a circulating hot water piping loop. The existing steam terminal heating equipment would also need to be replaced with new appropriately sized hot water terminal heating equipment for compatibility with the head end heating hot water systems. The existing steam terminal heating equipment has also exceeded its expected useful life span and is due for replacement.

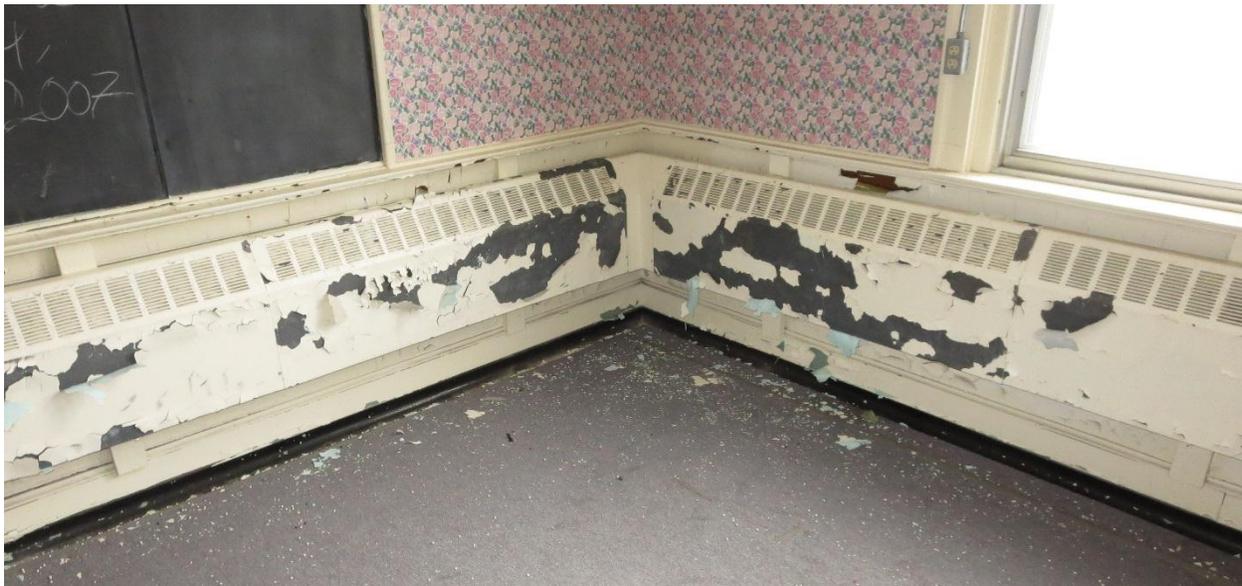
The two existing oil-fired steam boilers provide low pressure steam to terminal equipment throughout the existing building for heating. The majority of terminal heating equipment consists of steam heating finned tube radiation with slope topped enclosures located along walls with exterior exposure. The existing terminal heating equipment was operating at the time of the site visit.

Typical Steam Perimeter Finned Tube Radiation
